Ruapehu District Council
Report on River Valley Safety
Improvement Works

2009/10

April 2010

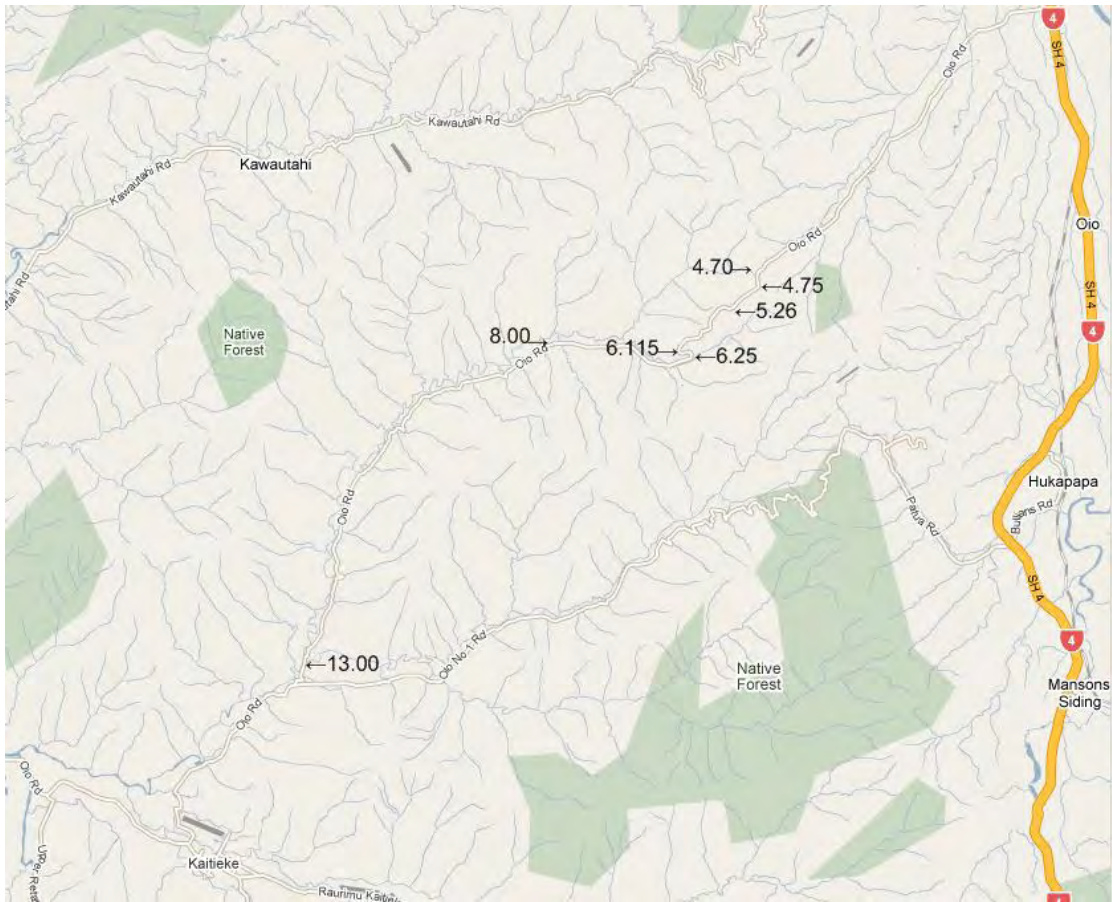
Figure 1. Oio Road safety improvement sites.

RP	Work Type	Description	Estimate
4,700	Signs	Sight rail in front of drop off	\$ 1,700
4,750	Environment	Remove dangerous overhanging tree	\$ 1,000
5,260	Signs	Sight rail in front of drop off	\$ 500
6,115	Signs	Sight rail in front of drop off	\$ 1,000
6,250	Signs	Sight rail in front of drop off	\$ 2,400
8,000	Signs	Hazard markers on power pole's close to the road	\$ 700
13,000	Signs	Place sight rails on the bridge approaches	\$ 700
30,000	Minor Imp	Sight benches at 30km peg	\$ 10,500
31,500	Environment	Remove trees over 35m length to improve visibility at curve	\$ 200
31,500	Drainage	Replace culvert with 375mm diameter culvert	\$ 2,800
32,655	Minor Imp	Sight bench 65m to improve visibility	\$ 1,700
33,620	Minor Imp	Sight benching over 165m to improve visibility. Stockpile pumice on flats below road for future use.	\$ 10,700
35,300	Minor Imp	Blind corner, wattle and pumice removal to improve visibility.	\$ 6,100

35,895	Minor Imp	Widen road, removal tree to improve visibility, and infill water table with riverrun	\$ 5,700
36,530	Minor Imp	Sight bench and remove approx 10 large poplars to improve visibility	\$ 1,700
37,670	Minor Imp	Widen 70 - 100m of road	\$ 4,900
38,000	Minor Imp	60m of sight benching and tree removal	\$ 2,100
38,565	Minor Imp	Provide site bench	\$ 1,300
39,590	Minor Imp	Remove 40m of overhanging rock, 20m sight bench and extend #254x1 pipe if possible.	\$ 4,500
41,000	Minor Imp	Provide 40m sight bench. Helens gravel to here for old earthworks cover	\$ 3,000
41,835	Minor Imp	Realign and sight bench.	\$ 7,000
41,835	Drainage	Replace culvert with 375mm diameter pipes. Use old pipe on access by culvert 271	\$ 2,800
42,800	Minor Imp	Realign and sight bench for 55m at Helens creek. Reuse gravels as subbase at other sites	\$ 4,600
Total			\$ 77,600

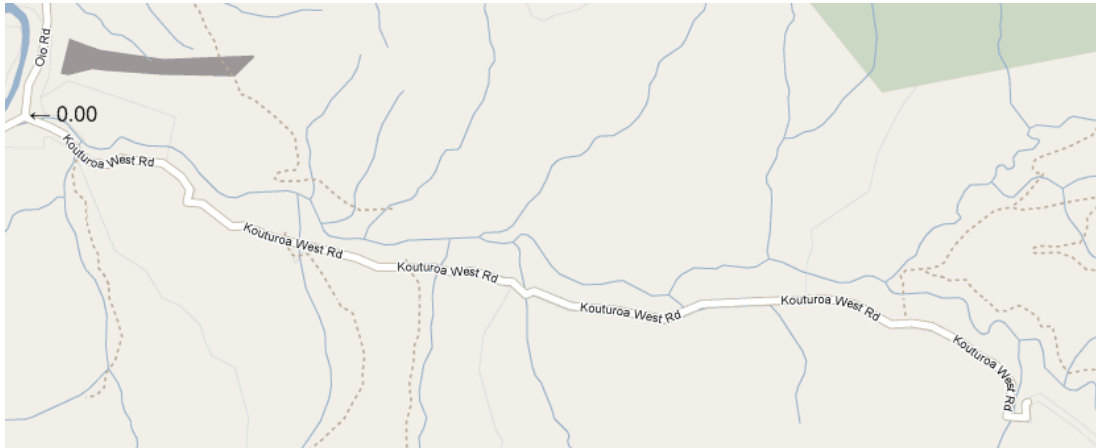
Figure 3. Kouturoa Road safety improvement sites.

RP	Work Type	Description	Estimate
0	Signs	Place "No Exit" sign	\$ 300
0	Signs	Place "SH 4" and "Owhango 31km" sign	\$ 300
Total			\$ 600

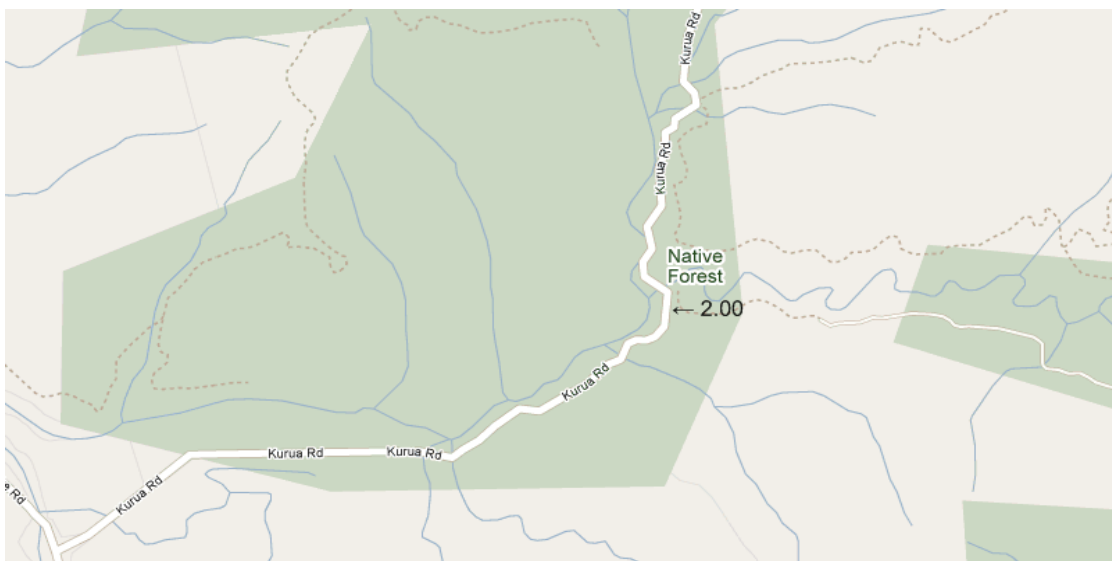
Figure 4. Kurua Road safety improvement sites.

RP	Work Type	Description	Estimate
2,000	Signs	Sight rail in front of drop off	\$ 1,700

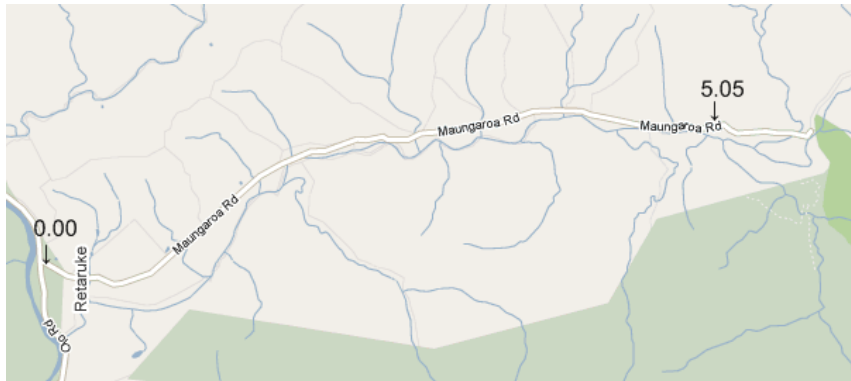
Figure 5. Maungaroa Road safety improvement sites.

RP	Work Type	Description	Estimate
0	Minor Imp	Reconstruct intersection	\$ 3,000
0	Signs	"Whakahoro"	\$ 300
5,050	Minor Imp	Truck turning area	\$ 2,200
Total			\$ 5,500

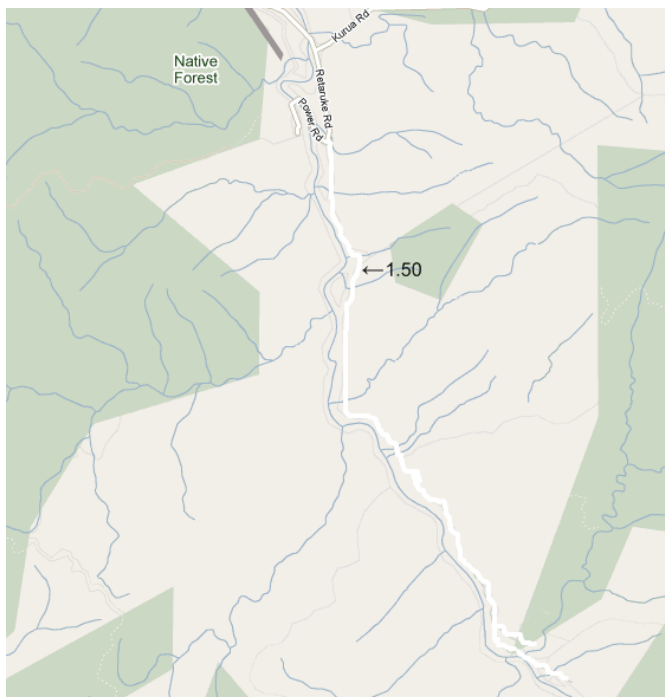
Figure 6. Retaruke Road safety improvement sites.

RP	Work Type	Description	Estimate
1,500	Signs	Sight rail in front of drop off	\$ 1,800

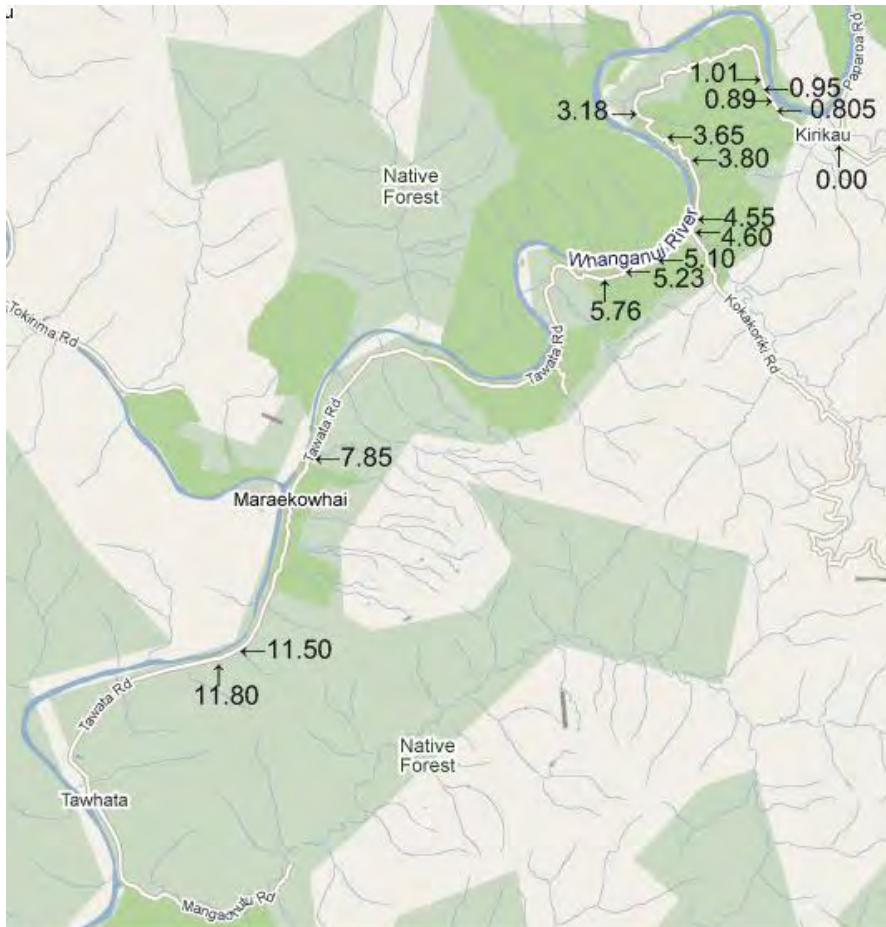
Figure 9. Tawata Road safety improvement sites.

RP Work Type	Description	Estimate
0 Signs	New no exit sign required	\$ 300
805 Signs	Sight rail at Culvert 4 outlet	\$ 500
890 Signs	Sight rail above Culvert 6	\$ 500
950 Signs	Sight rail Below 1km peg	\$ 500
1,010 Signs	Sight rail in front of drop off	\$ 500
3,180 Signs	Sight rail Approx 60m past Culvert 16	\$ 500
3,650 Signs	Sight rail Approx 150m past Culvert 20	\$ 500
3,800 Signs	Sight rail in front of drop off	\$ 500
4,550 Environment	Cut vegetation for sight distance	\$ 500
4,600 Minor Imp	Seal bridge approaches	\$ 9,000
5,100 Signs	Sight rail at culvert 32 dropout	\$ 500
5,230 Signs	Sight rail in front of drop off	\$ 500
5,760 Signs	Sight rail before Culvert 36	\$ 500
7,850 Signs	Sight rail by Culvert 51	\$ 500
11,500 Drainage	Replace Culvert 90. Rock wall. Leave trees	\$ 3,500
11,800 Signs	Sight rail past Culvert 91	\$ 500
Total		\$ 19,300

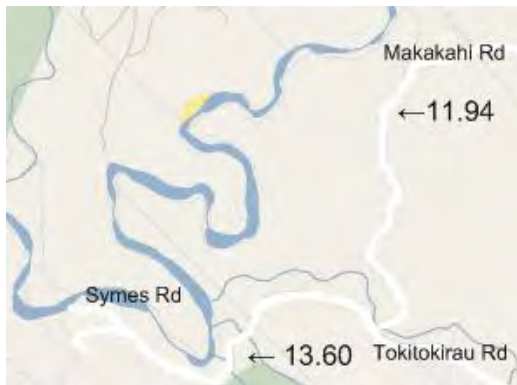
Figure 10. Makakahi Road safety improvement sites.

RP	Work Type	Description	Estimate
11,940	Signs	Sight rail on blind rise corner	\$ 700
13,600	Signs	Sight rail along 100m bluff to river	\$ 3,500
Total			\$ 4,200

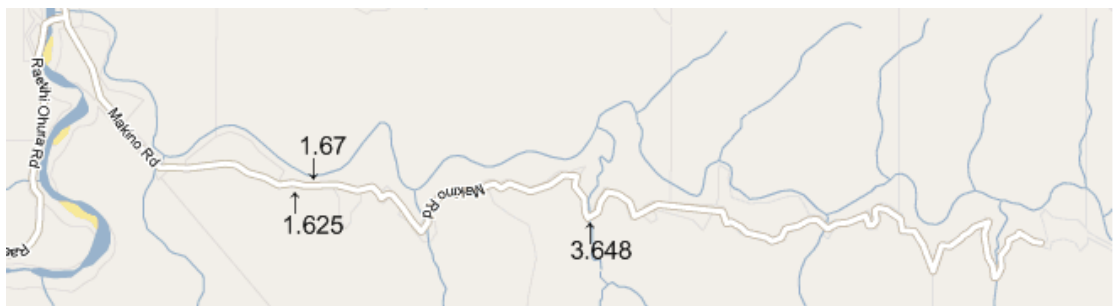
Figure 11. Makino Road safety improvement sites.

RP	Work Type	Description	Estimate
1,625	Minor Imp	Widen approach to bluff	\$ 4,500
1,670	Minor Imp	Widen bluff start and remove toe of rest of bluff (has significant cost; thus, will be spread over the next couple of years)	-
3,648	Signs	Sight rail at inside bend above culvert30	\$ 700
4,730	Emergency	Minor slips on last years site	\$ 400
Total			\$ 5,600

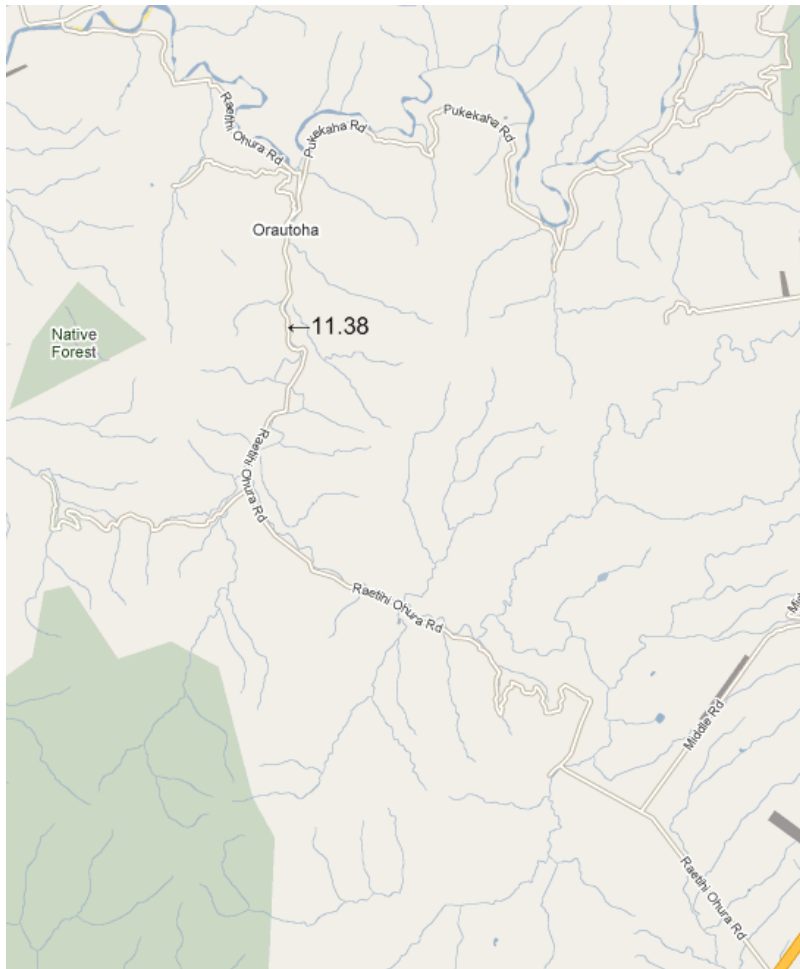
Figure 13. Raetihi Ohura Road safety improvement sites.

RP	Work Type	Description	Estimate
11,380	Signs	Safety Issue: Relocate Telecom stay away from seal edge	\$ 150
