# **Ruapehu District Council**

## **Assessment of Water and Sanitary Services**

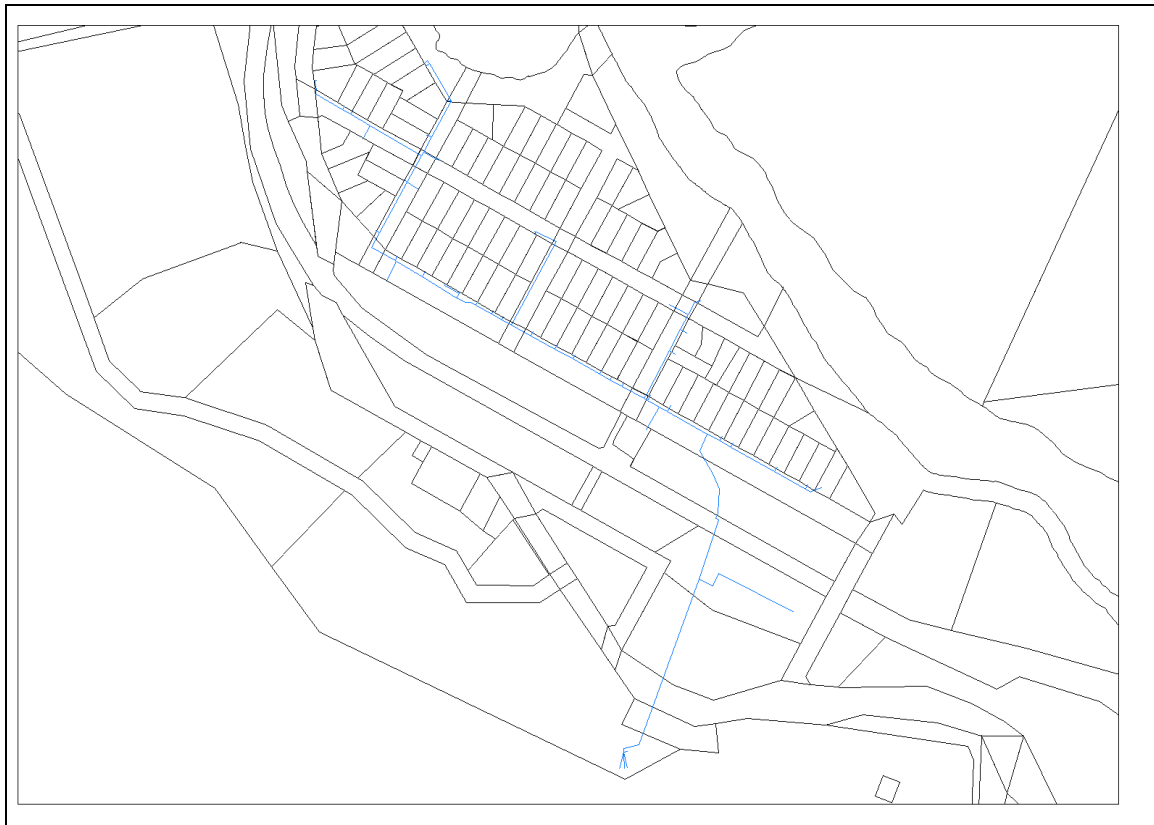
Figure 3: Piriaka Infrastructure

In 1986 the Council took over the operation and maintenance of the intake, reservoir, and reticulation. There are 43 properties currently connected to the reticulation. Regular monitoring of the supply has shown that one of the springs sometimes becomes contaminated with colony forming units during the summer months. In recent times there has been some incidents of contamination of the second spring. When contamination is detected Council isolate the contaminated spring from the supply and monitor the spring until the contamination is cleared before taking back into service. The reservoir water is also chlorinated temporarily until treated water is cleared of the contamination. Boil water notices are issued to consumers. The cause of the contamination is unknown and it may be necessary therefore to install some means of disinfecting the water permanently before it is fed into the reticulation sometime in the future.

The Ministry of Health has not yet graded the Piriaka water supply. However the water supply will not obtain the minimum Grade C because of the occasional contamination that is occurring and the absence of provision for disinfection.

The reticulation system is not suitable to sustain any standard of fire flows. However a 22.5m<sup>3</sup> concrete tank with a hydrant installed at the outlet to the tank has been provided at one end of the distribution system for fire fighting water supply.

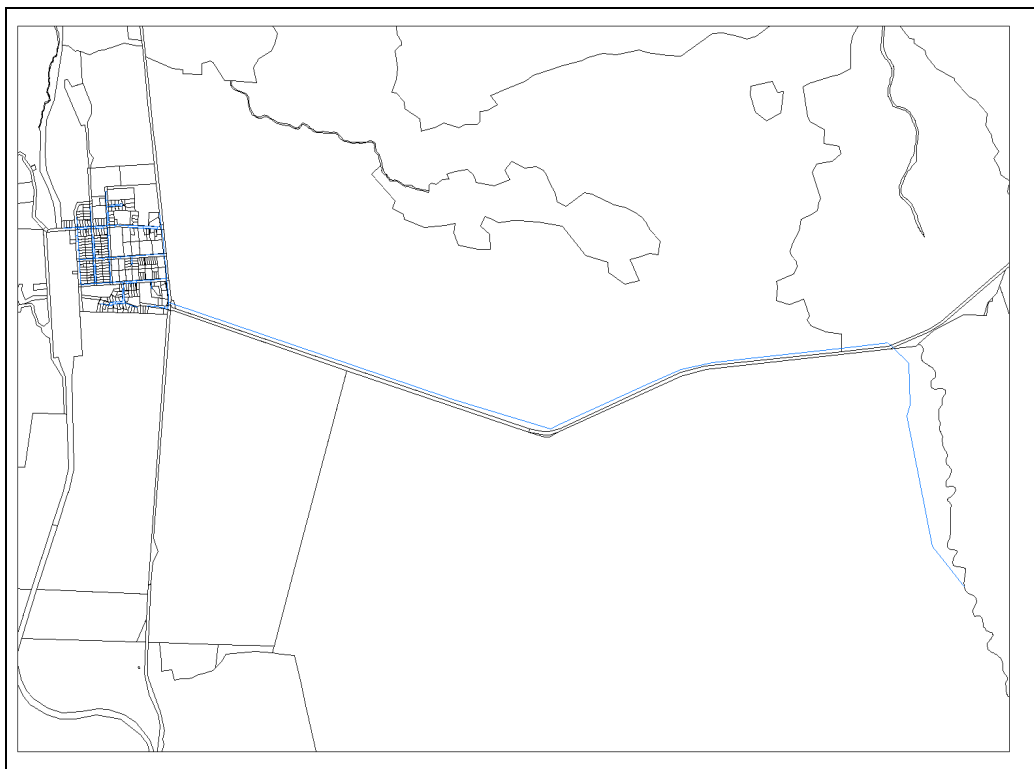
Figure 4: National Park Infrastructure

Water is taken from the Mangahuaia Stream within the Tongariro National Park and piped 1,982 metres to a treatment plant alongside State Highway No.47 via a 150mm diameter HDPE and uPVC pipeline. Treatment consists of filtration and chlorination. Treated water is then piped 3,502 metres to a 500m<sup>3</sup> timber tank reservoir, which is 2,305 metres from the commencement of the reticulation. The complete system is gravity fed, including the filter backwash.

None of the properties in National Park are metered. The Ministry of Health has not yet assessed the National Park water supply. However, the treated water meets the requirement of Drinking Water Standards New Zealand 2000 for E coli compliance.

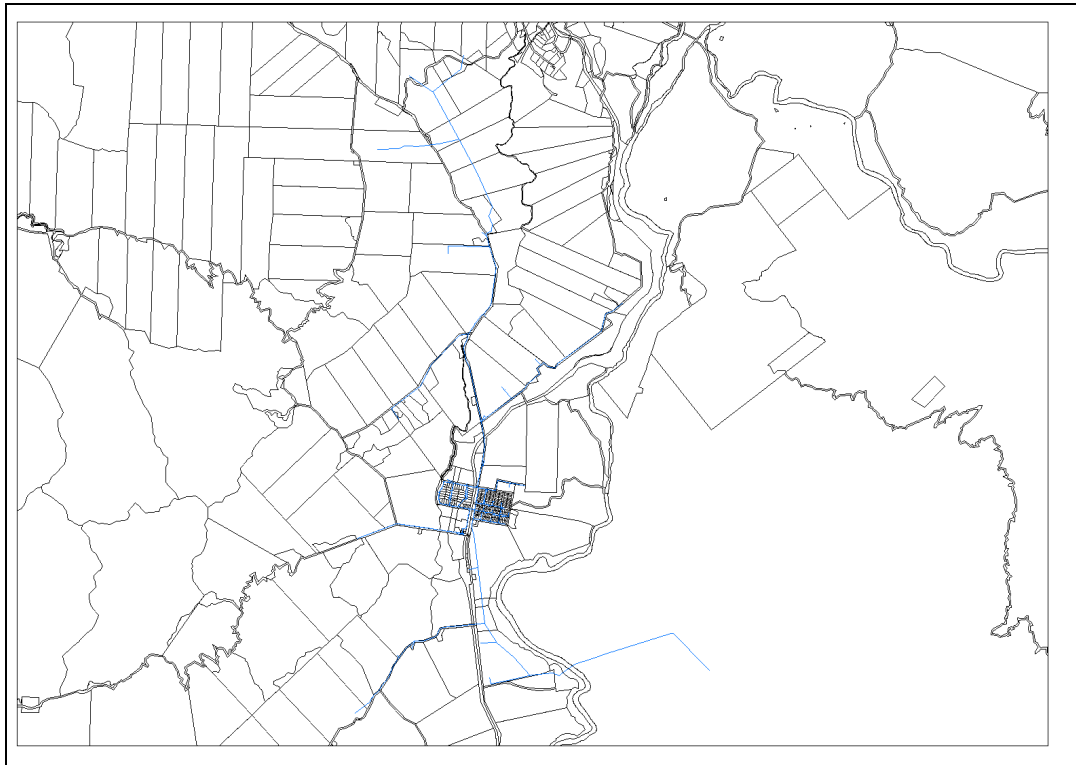
Figure 5: Owhango Infrastructure

Water is taken from a stream within the Tongariro Forest known locally as Deep Creek. The intake structure is approximately 3.5 kilometres southeast of the township. The catchment above the intake is 1,270 hectares in area, and consists mainly of cut over second growth native bush, which was logged in the 1920's.

Water is piped 4,070 metres to a treatment plant sited on land owned by Owhango Farms Ltd. Treatment consists of screening and chlorination. Treated water is then piped to a 270m<sup>3</sup> timber tank reservoir, and from the tank to the reticulation. The entire system is gravity fed.

The catchment above the intake is unprotected, and entirely within the Tongariro Forest. The area is popular with trampers, mountain bike riders, and recreational hunters. The forest is well stocked with deer and wild pigs. Faecal coliform contamination of the raw water is therefore very likely. The catchment is mostly covered in second growth bush, having been logged in the 1920's. There is a remote possibility that contamination could occur from an eruption of Mount Ruapehu or Mount Ngauruhoe

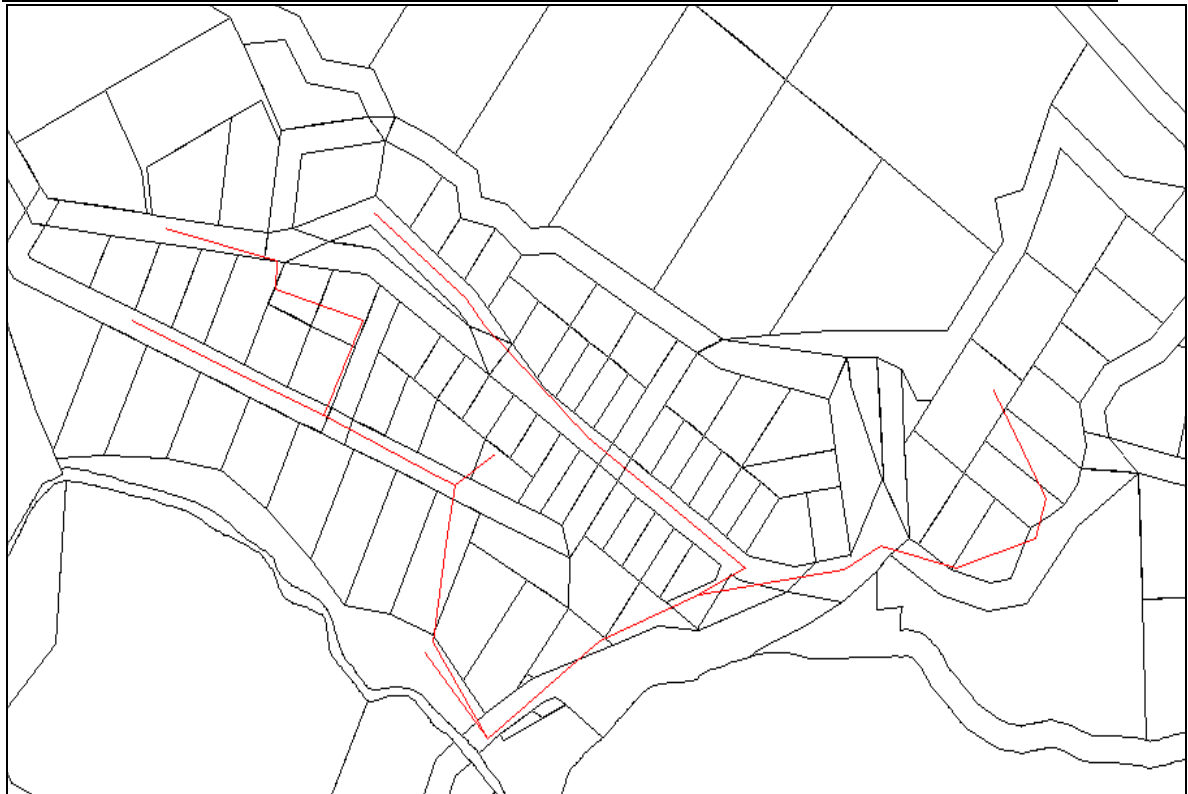
Figure 13: Pīpiriki Sewerage Infrastructure

The present system was designed to cater for a population of around 200 persons and is sufficient for the needs of the community it currently serves. However it is considered that the increase in usage experienced over the summer months as a result of visitors coming off the Whanganui River and using the public facilities places an increased loading on the treatment plant. To date this has not had an adverse effect on the facility

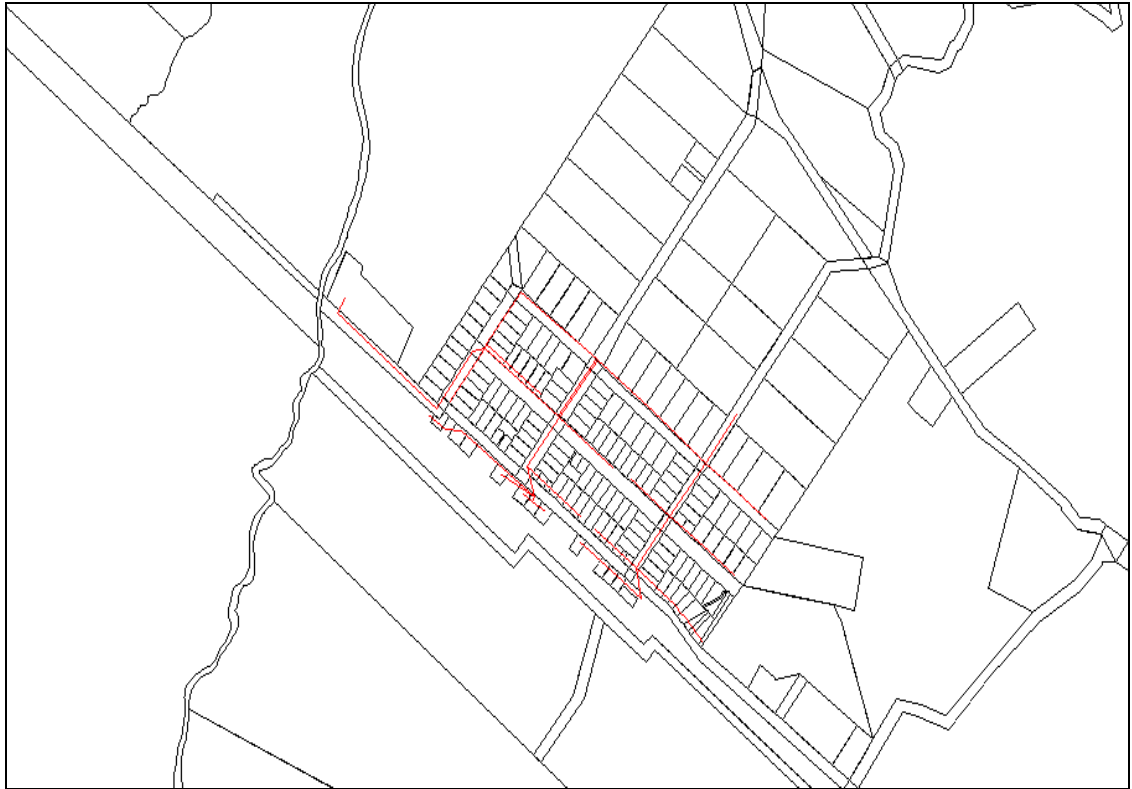
Figure 14: Rangataua Sewerage Infrastructure

The sewer pump station is a usual wet well/submersible pump type facility equipped with Jung submersible pumps set up in a duty/standby configuration. The pumps pump collected sewage to the treatment plant via a 80mm diameter rising main, 800m long.

The Rangataua sewage treatment plant is located on the unsealed section of Neil Street to the east of the township and consists of two ponds operated in series. The primary pond has a surface area of 1,608m<sup>2</sup>, while the secondary pond has a surface area of 1,089m<sup>2</sup>. The depth of each pond is 1.35 and 1.25 metres respectively. Treated effluent is discharged to a wetland alongside the ponds with three timber weirs to provide retention for settlement of carry over sludge and additional treatment by the naturally occurring plants. The maximum depth of the pond behind the weir is limited to 200mm to provide optimum condition for the growth of wetland vegetation.
