Waimarino-
Waiouru
Community
Board

Agenda

Thursday, 3
June 2021
at 6:00 PM

Detailed Seismic Assessment

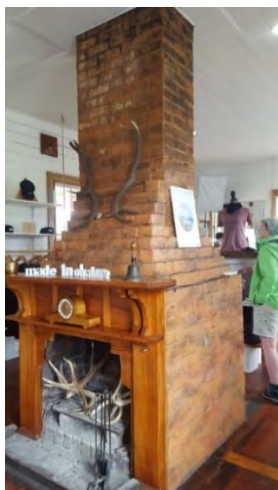
- 5.2 The DSA indicates that the existing building's seismic capacity is less than 15% NBS, limited by two heavyweight chimneys (chimneys 1 and 3) through the roof. Other elements that are less than the legal requirement of 34% NBS include chimney 2, the platform canopy, ceiling and subfloor bracing. The chimneys are shown in **Figure 1**:

Internal Chimney (1) in shop (Black Chateau Textiles)

- 5.3 The DSA recommended the chimneys be demolished and replaced with suitable light-weight replicas, however Heritage NZ advised that replica chimneys are not in keeping with the Heritage Status of the building and that the chimneys should be strengthened rather than replaced.
- 5.4 A Conservation Architect has worked with Miyomoto to provide an updated proposal for strengthening the chimneys (**Attachment 2**) by a method which has been approved by Heritage NZ.
- 5.5 A concept estimate has been provided for the new proposal for strengthening the chimneys (**Attachment 3**).
- 5.6 Improvements for the building to achieve a rating of above 34%NBS are summarised in **Table 1**.

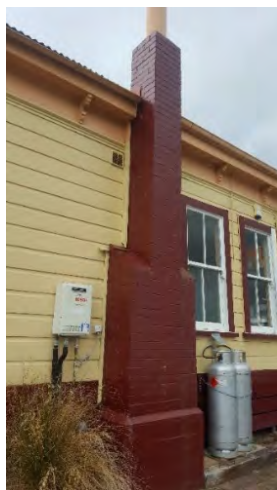
External Chimney (2) in shop end of building

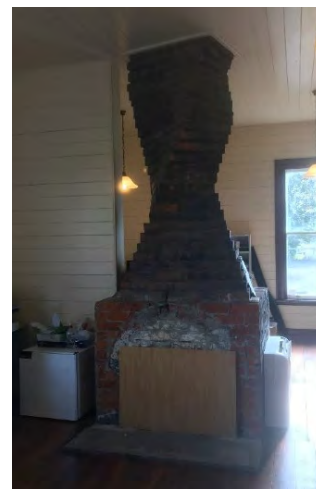
Internal Spiral Chimney (3) in ex-Visit Ruapehu Rooms

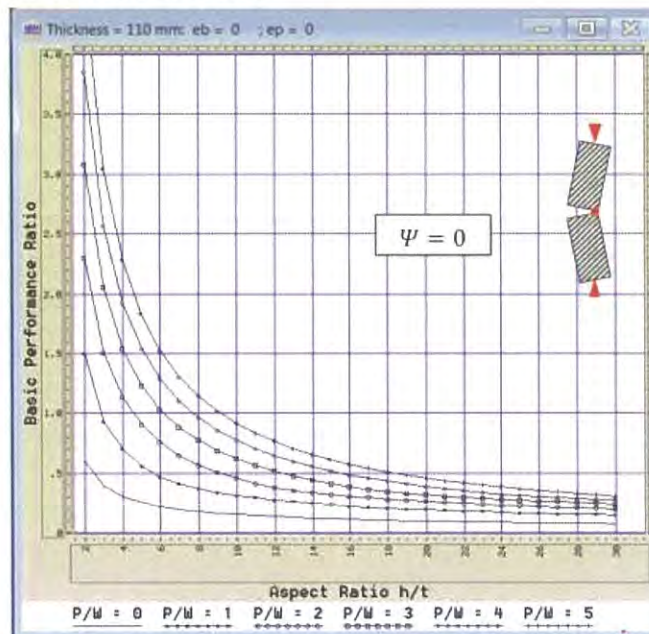
BPR (Basic performance ratio) chart for eb=0 and ep=0

(e) For $e_b = 0$ and $e_p = 0$ ($t_{Gross} = 110$ mm)

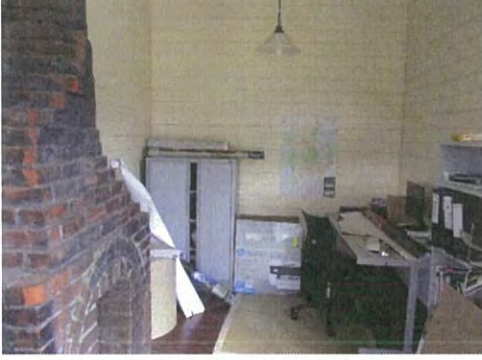
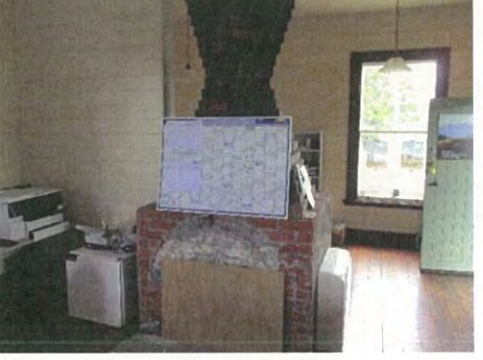
<p>Chimney 3</p>

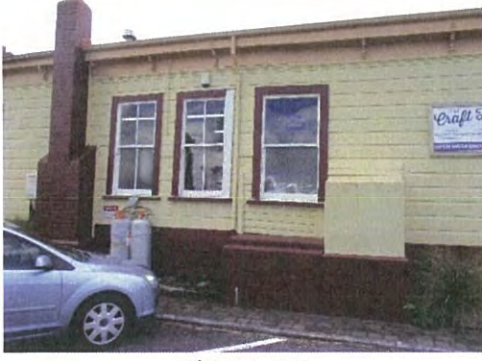
<p>Chimney 2</p>

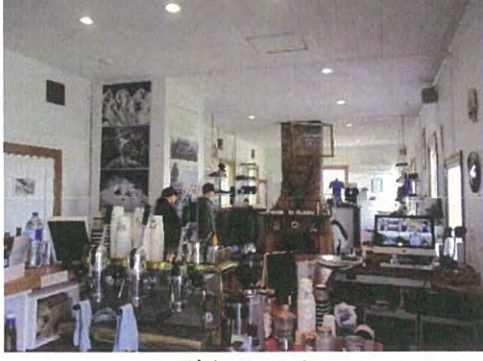
<p>Chimney 1</p>

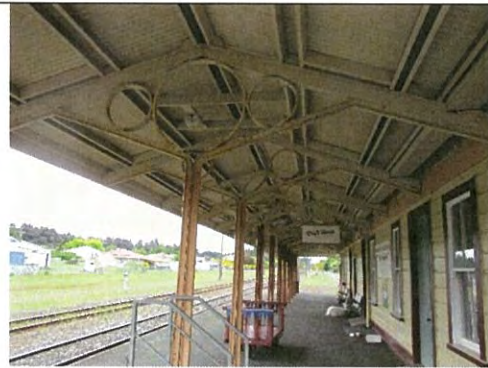
Canopy

- Canopy – there is a large platform canopy, constructed with cantilever steel cross-beams and longitudinal timber purlins. There is no roof bracing observed in the platform canopy.

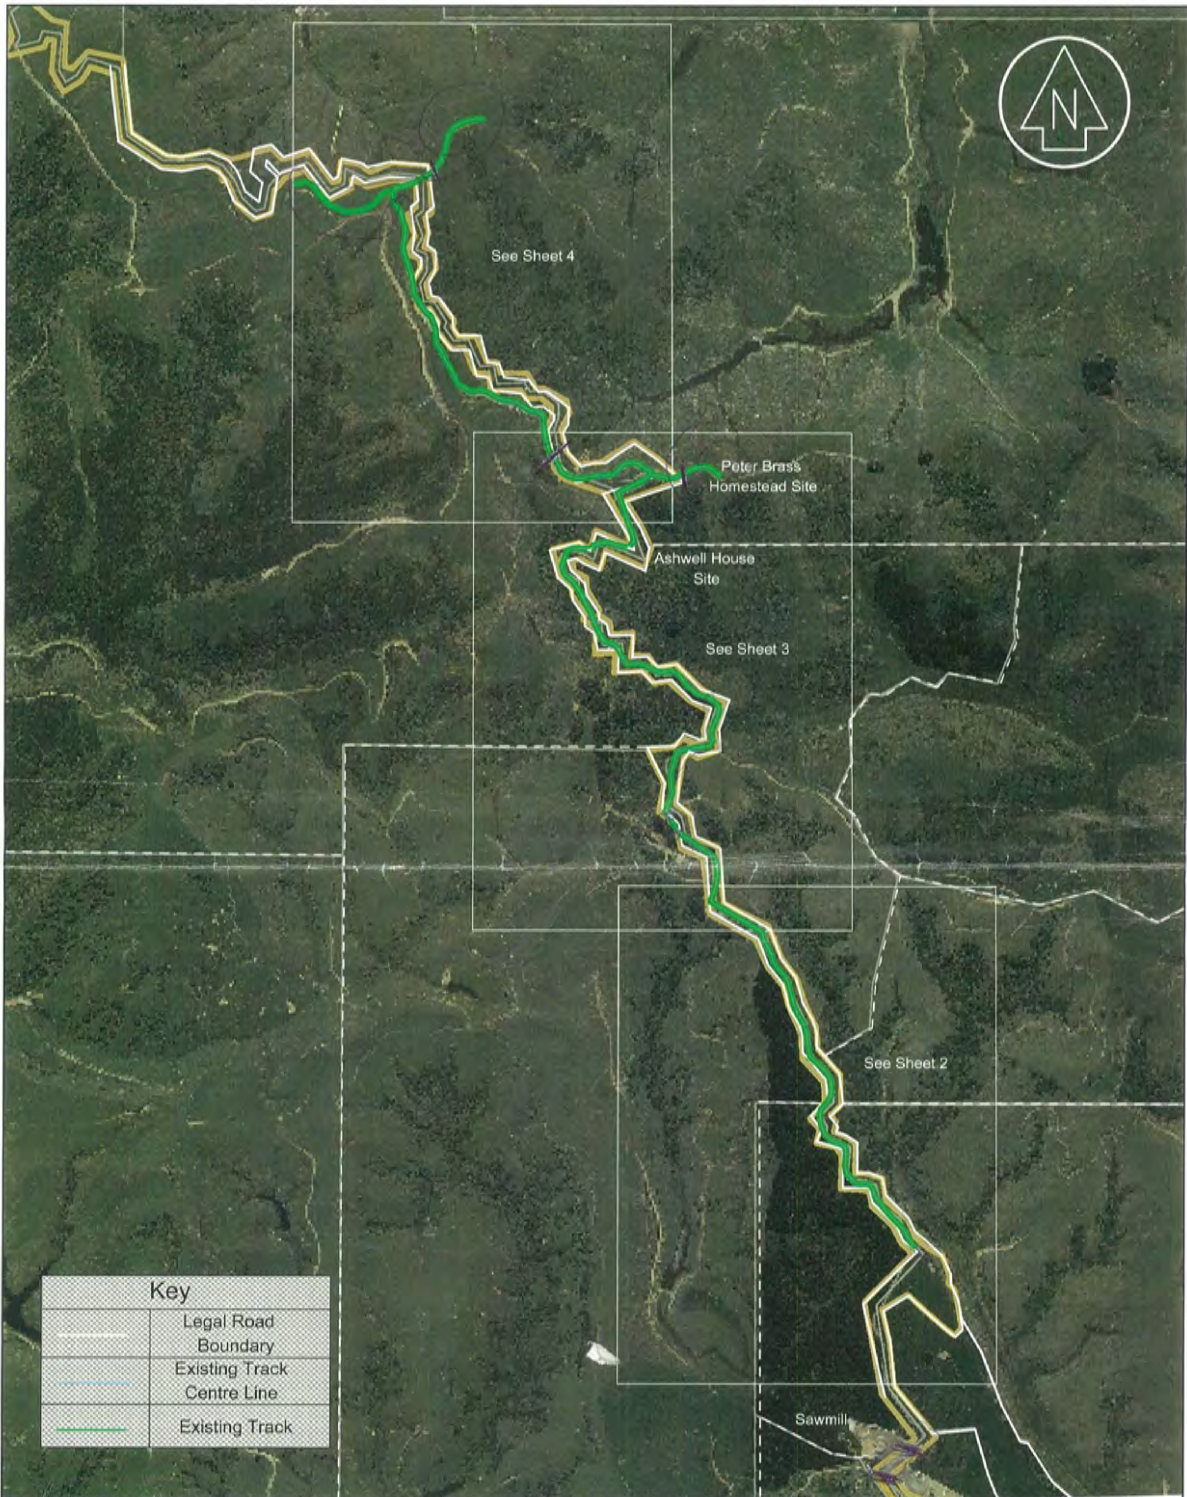
ATTACHMENT 1: MAP- AMEKU WALKWAY

<p>Ameku Road Legal Boundary & Track Formation</p>	Drawn		  <p>Plateau Surveyors Ltd. 43 Clyde Street, OHAKUNE Ph / Fax (06) 385-9333 Mobile 027-201-9000 email office@plateau-surveyors.co.nz</p>	Scale: 1:7000 @ A3																		
	Checked	GP		PS Ref: RP-191201
