Lovett, A.; Deligne, N.; Clark, K.; van der Raaij, R.; Rawlinson, Z. 2014. Assessment of the Waimarino Plains Water Supply, *GNS Science Consultancy Report 2014/99*. 62 p

active faults. Surface water sources (rivers, streams and springs) are the most at risk, as supply sources are located on or close to an active volcano and within drainage channels in which re-mobilised ash may travel. In addition, streams and associated water treatment plants are vulnerable to ash fall hazards. Of additional concern is that the current Raetihi and Ohakune WTP's are located on, or within the 150 m buffer zone of active faults.

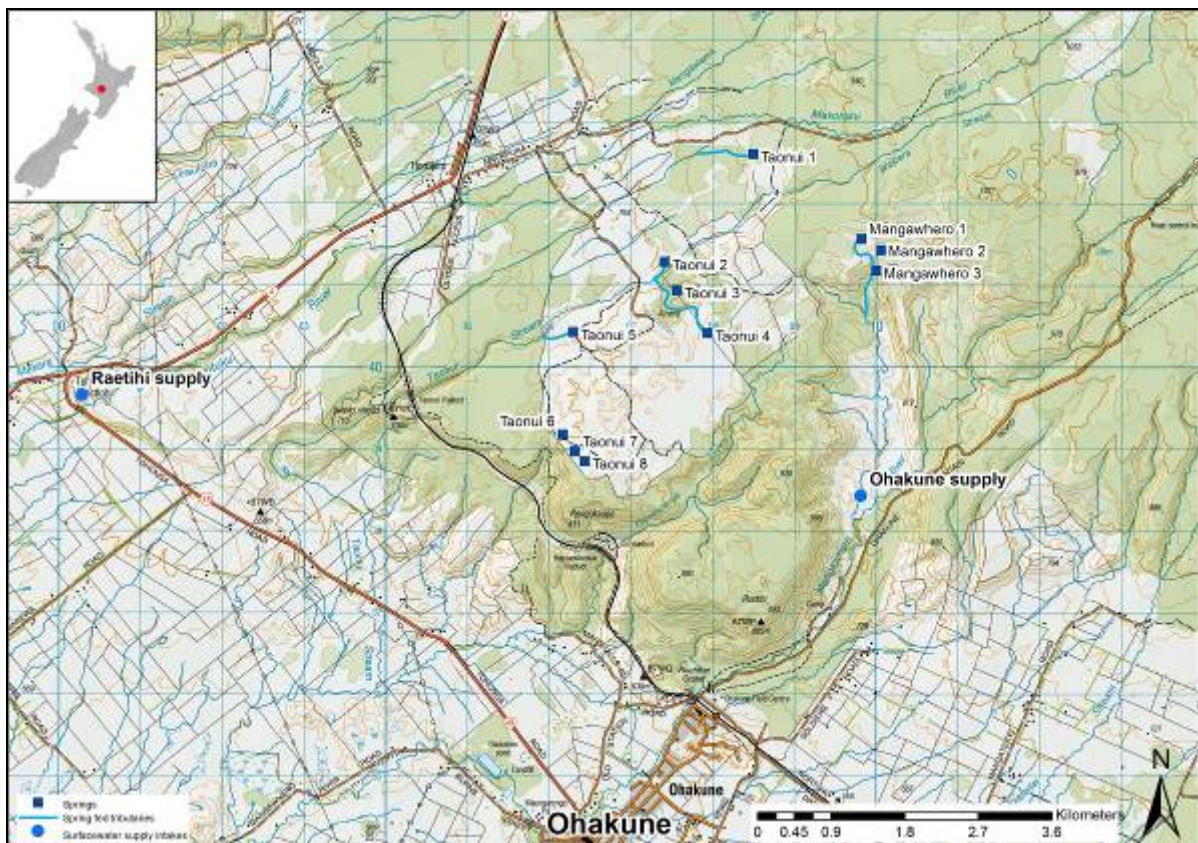
Figure 2.2: Location of documented springs in the upper catchments of the Taonui and Mangawhero Streams. (Westcott, personal communication 2014).

Known springs within the study area have been located based on information supplied by RDC (Figure 2.2) (Westcott, pers. comm. 2014). Springs have been named in this report based on the primary tributary in which they flow into. For clarification, any previous documentation of the spring naming has been provided (Table 2.3).

The Mangawhero River has three documented springs which emerge from the north of the stream and contribute to stream flow (Mangawhero 1, 2, and 3). There are no known datasets of spring flow rates or chemistry for these springs. There are 8 documented springs that occur within the upper Taonui Stream catchment. Several of these springs (Taonui 1, 2, 3, and 4) have previously been reported as Bishop's Spring, or variations of Bishop's Spring. These springs have been estimated to contribute  $10,000 \text{ L day}^{-1}$  to the Taonui Stream (Opus, 2001), although it is unknown how this value was generated. Two gauging measurements of Bishop's Spring (Taonui 1) were conducted concurrently on the 25.06.1999, from 11:00 – 11:20 am, and from 11:30 – 11:50 am. Results indicated a measured flow rate of  $38 \text{ L sec}^{-1}$

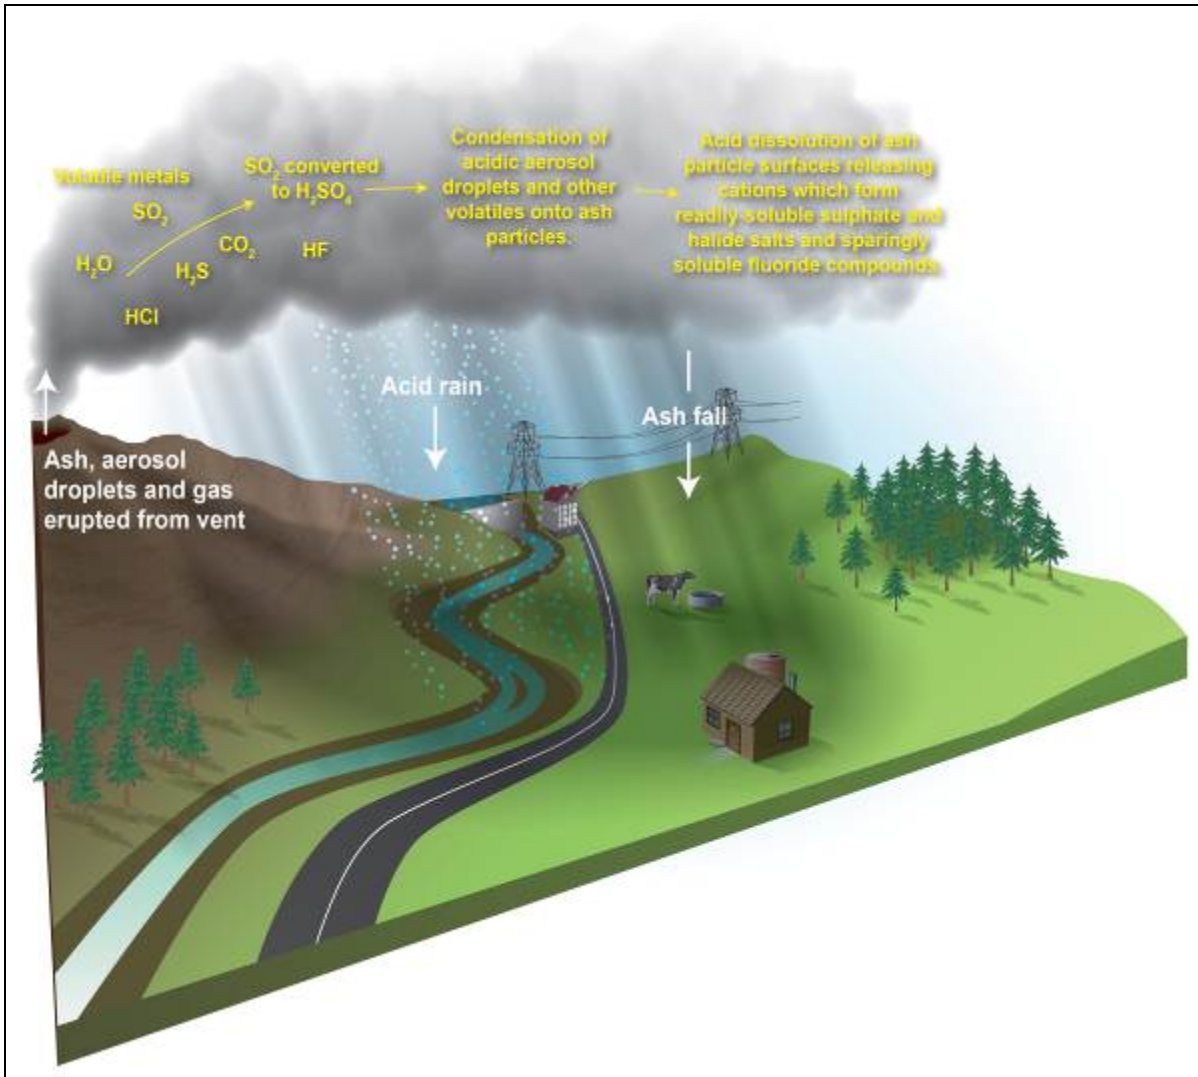
Figure 3.1: Volcanic plume processes causing water contamination.

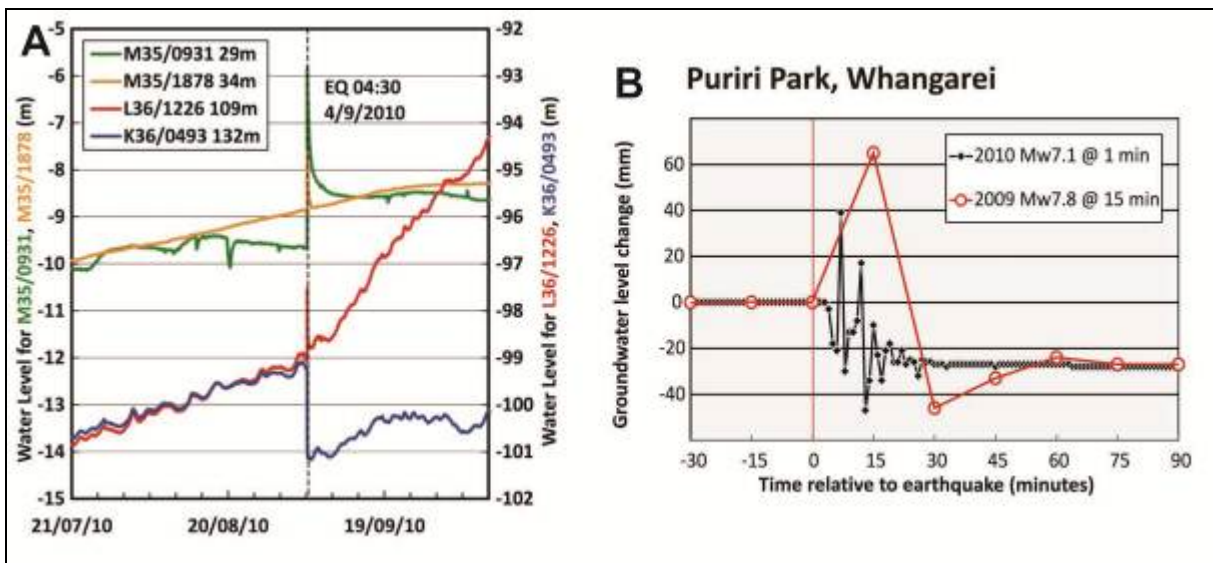
Figure 3.10: Examples of groundwater responses to the Darfield earthquake. (A) Responses from wells at intermediate (M35/0931, M34/1878) and deep (L36/1126, K36/0493). Note the coseismic spikes and the slope changes. (B) Groundwater oscillations recorded in a Whangarei bore hole, the Darfield earthquake response was recorded at 1 minute intervals (black line), and the 2009 Dusky Sound earthquake response was recorded at a 15 minute interval (red line). Figures from Cox *et al.*, 2012.

The Darfield earthquake, on the Greendale Fault, caused short term (minutes-hours), short term (days), and long-term (>1 year) changes in groundwater levels in the Canterbury region (Cox *et al.*, 2012; Gulley *et al.*, 2013). The Canterbury plains are underlain by alluvial and (towards the coast) fine-grained estuarine sediments; unconfined, semi-confined and confined aquifers underlie the region and are an important water resource for drinking water and agriculture. Of the 257 wells in the Canterbury region, 161 wells recorded the groundwater response to the earthquake. Groundwater responses included local groundwater level increases of >20 m around the Greendale Fault, particularly in deep aquifers (>80 m), whereas decreases occurred in coastal confined aquifers beneath

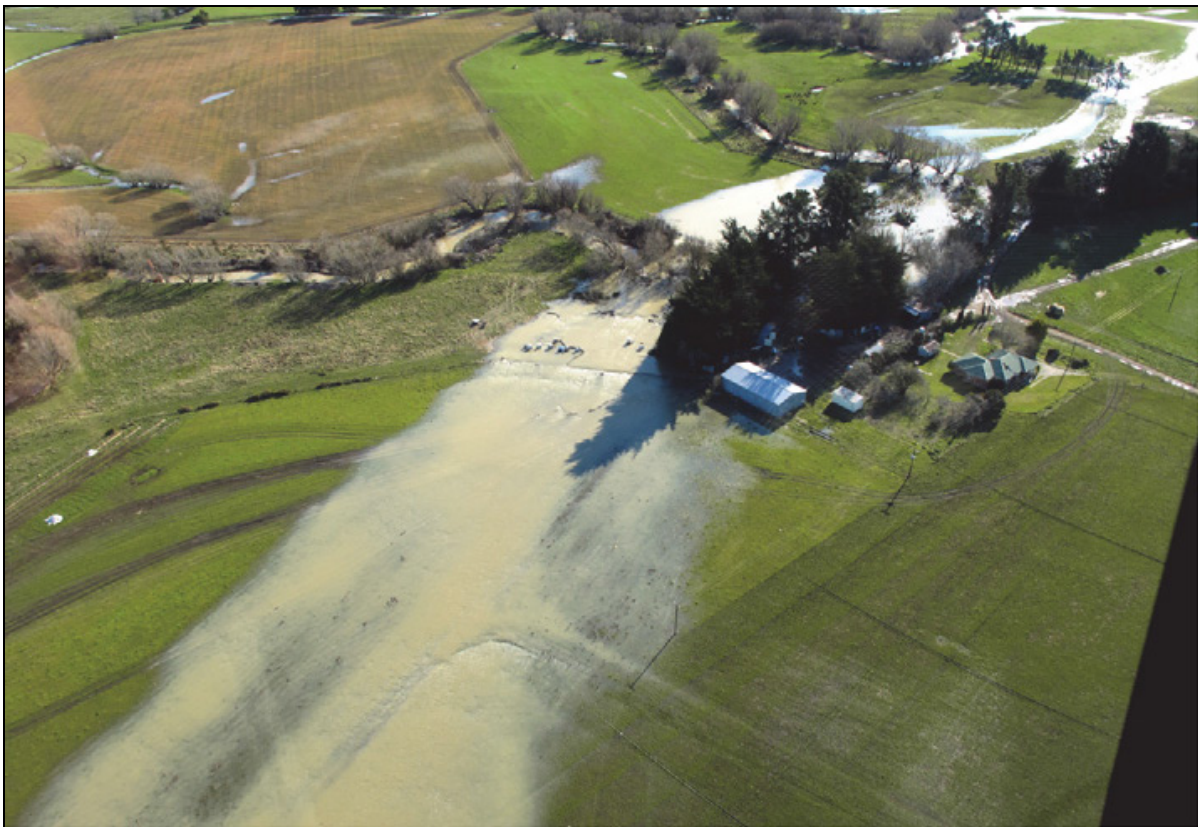
Figure 3.12: The sinuous course of the Hororata River, flowing from upper right to upper left, is crossed by the fault in this westward view, taken 4 September. A significant portion of the river's flow is diverted towards the lower left, along the downthrown side of the fault. Photo and caption source: Barrell *et al.*, 2011.

A further way in which seismic activity can affect water supply is through direct, physical disruption of the stream bed. Earthquakes that rupture the ground surface can disrupt, divert or block surface water flow; an example of this is the September 2010  $M_w$ 7.1 Darfield earthquake on the Greendale fault. Rupture of the Greendale fault temporarily diverted the course of the Hororata River (Figure 3.12, Barrell *et al.*, 2011), however, the river was relatively quickly restored to its former course by earthworks undertaken by the landowners. Permanent diversion of rivers and streams due to fault rupture is not known to be a widespread and common effect of earthquakes, most effects are temporary, but the Darfield example shows it can cause significant short term problems, which would be amplified if the stream affected was used as a water source. Earthquake-induced landslides (or landslides of any cause, such as rainfall-induced) can also block rivers and streams, and/or deliver large pulses of sediment to rivers; the sediment pulse could be a potential problem if there was a water intake downstream of the landslide.

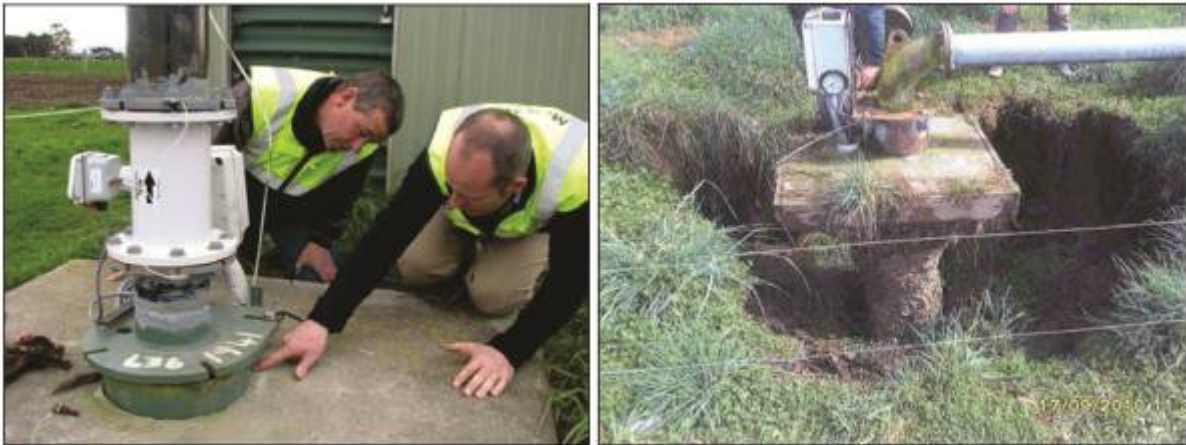
Figure 3.13: Examples of damage to wells caused by the  $M_w$ 7.1 earthquake. Some well heads rose out of the ground, while others were affected by settling/subsidence around the annulus (photos supplied by H. Rutter, Aqualinc, via Zemansky *et al.*, 2012).

Ground shaking and ground surface rupture caused by an earthquake have the potential to damage water supply infrastructure, particularly if the infrastructure was proximal to, or crossing over a surface rupture. The most relevant example of damage to water supply infrastructure is from the 2010-2011 Canterbury earthquake sequence. Christchurch's water supply systems were badly damaged, particularly by the 22 February  $M_w$ 6.3 earthquake. Figure 3.13 shows examples of damage to wells and Table 3.3 shows a summary of the damage to the fresh water supply system.
